Histoire de Fracture: Le Titan(ic)

David PESENTI ROSSI

APPAC 2013

ACTUALISATIONS ET PERSPECTIVES
EN PATHOLOGIE CARDIOVASCULAIRE

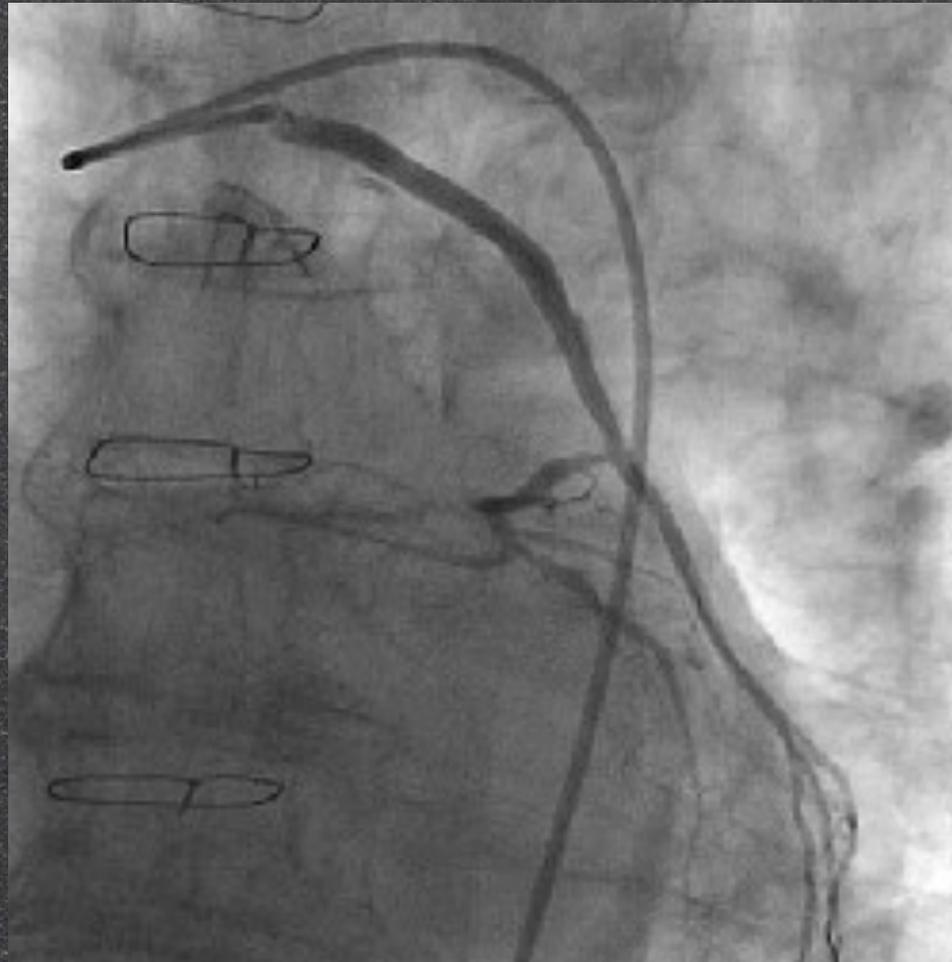
SCA 09/2011:

Anastomose Prox Saph-Mg → BMS TITAN 3.5x19

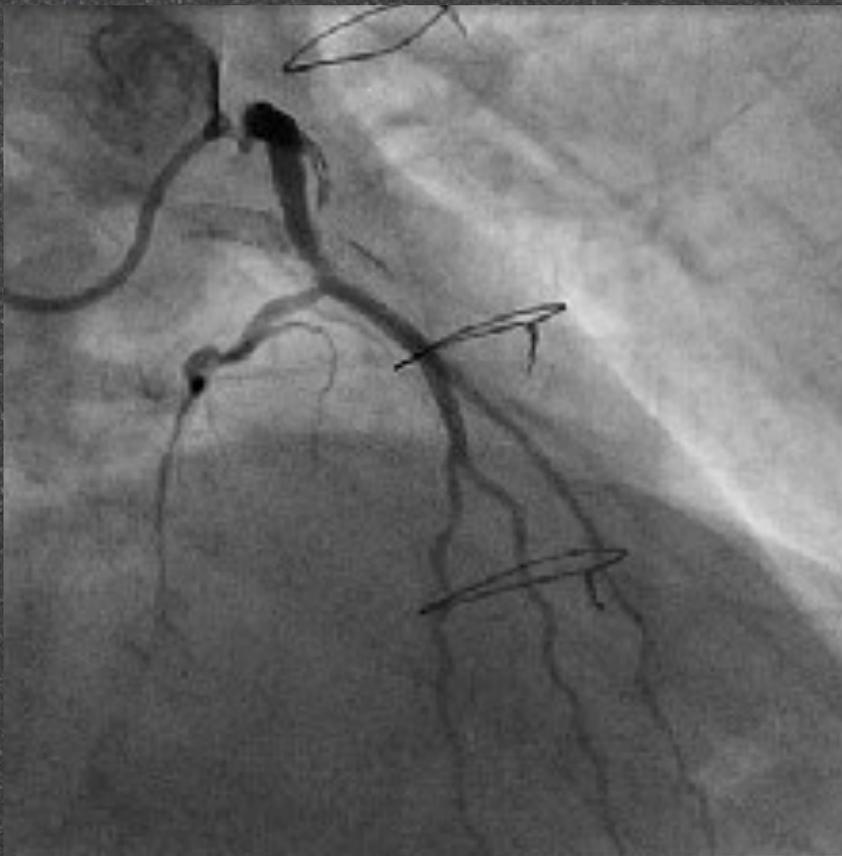
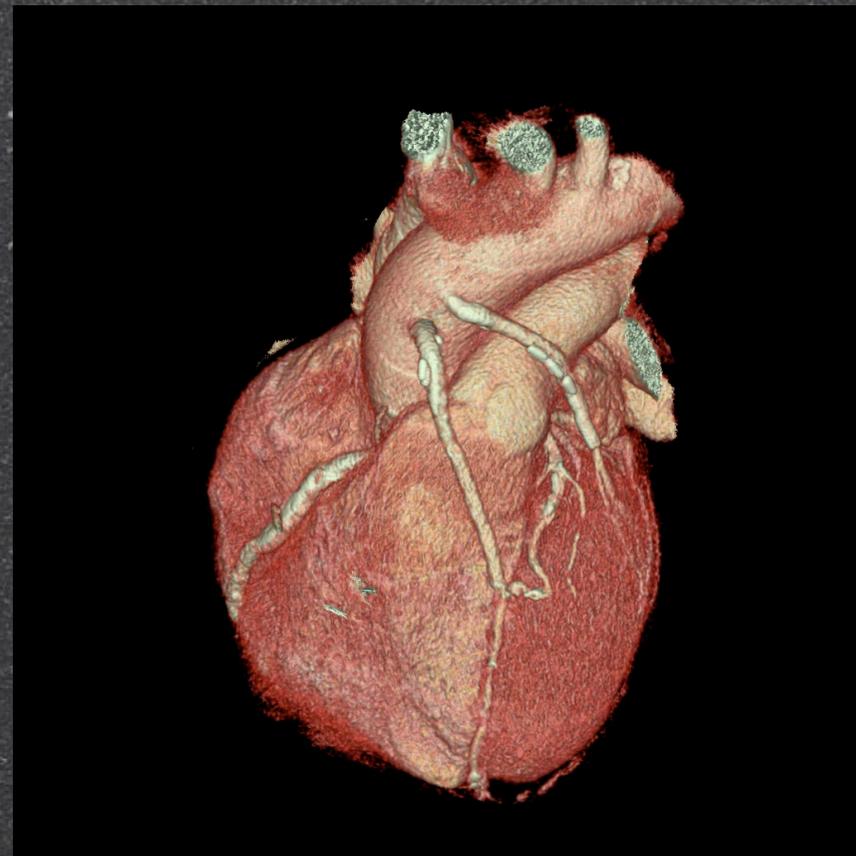
*Récidive SCA 11/11:
Resténose intra-stent / Anastomose Prox Saph-Mg
Pré-dilatation au ballon*

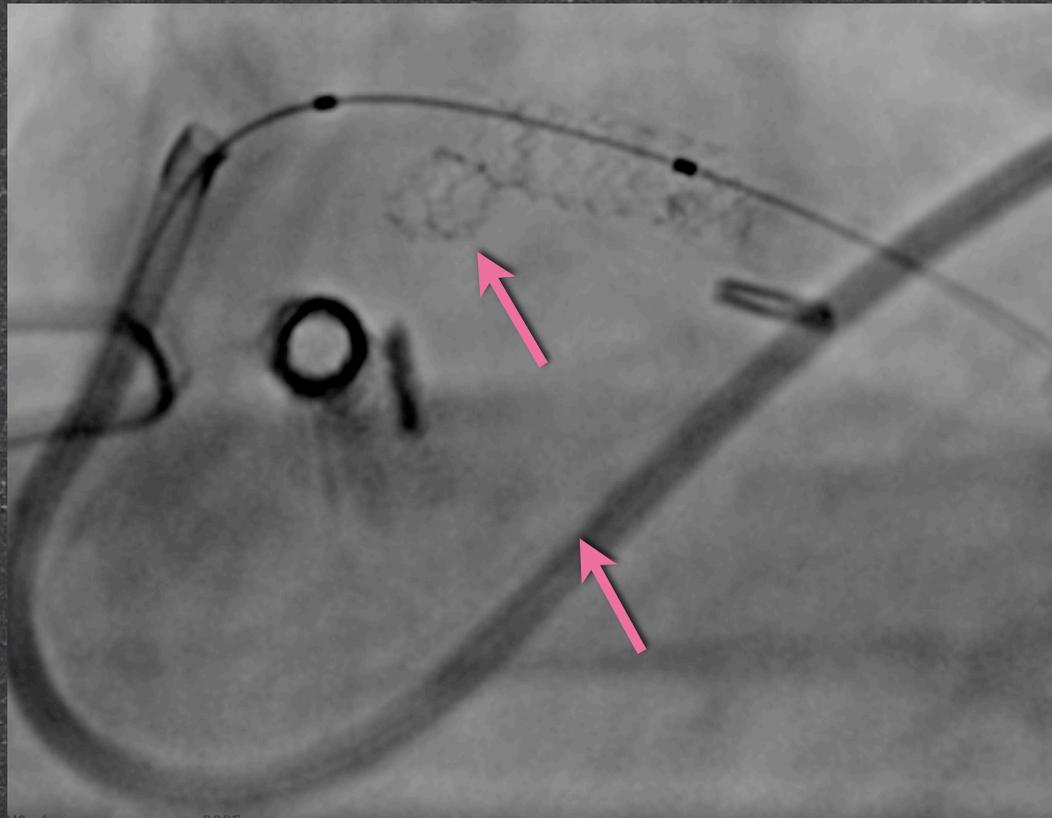
*Récidive SCA 11/11: Resténose intra-stent
Pré-dilatation / Anastomose Prox Saph-Mg*

Stent Boost: Fracture du BMS

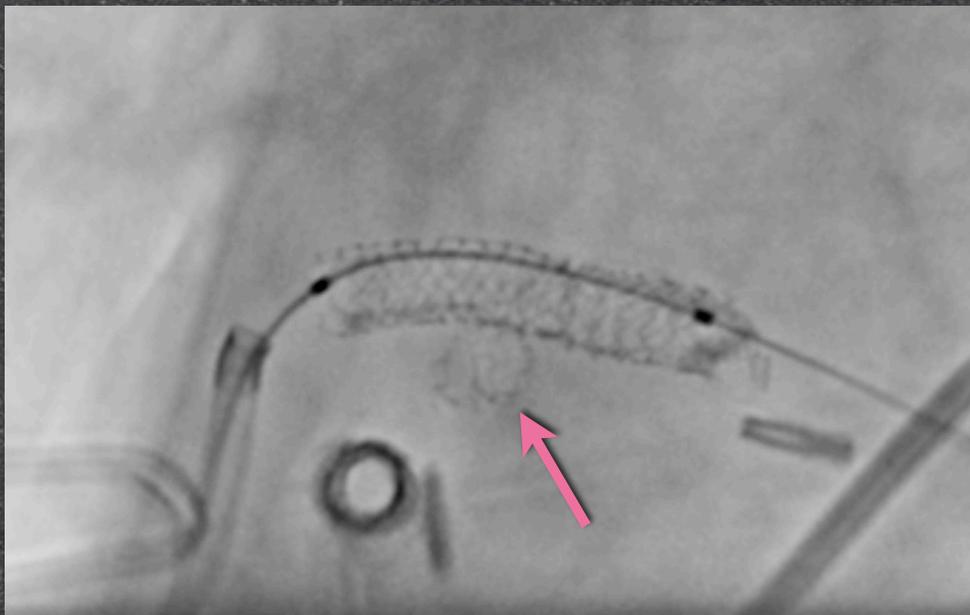
Récidive SCA 11/11:

Fracture Stent BMS (Titan) / DES (Xience) 3.5x23

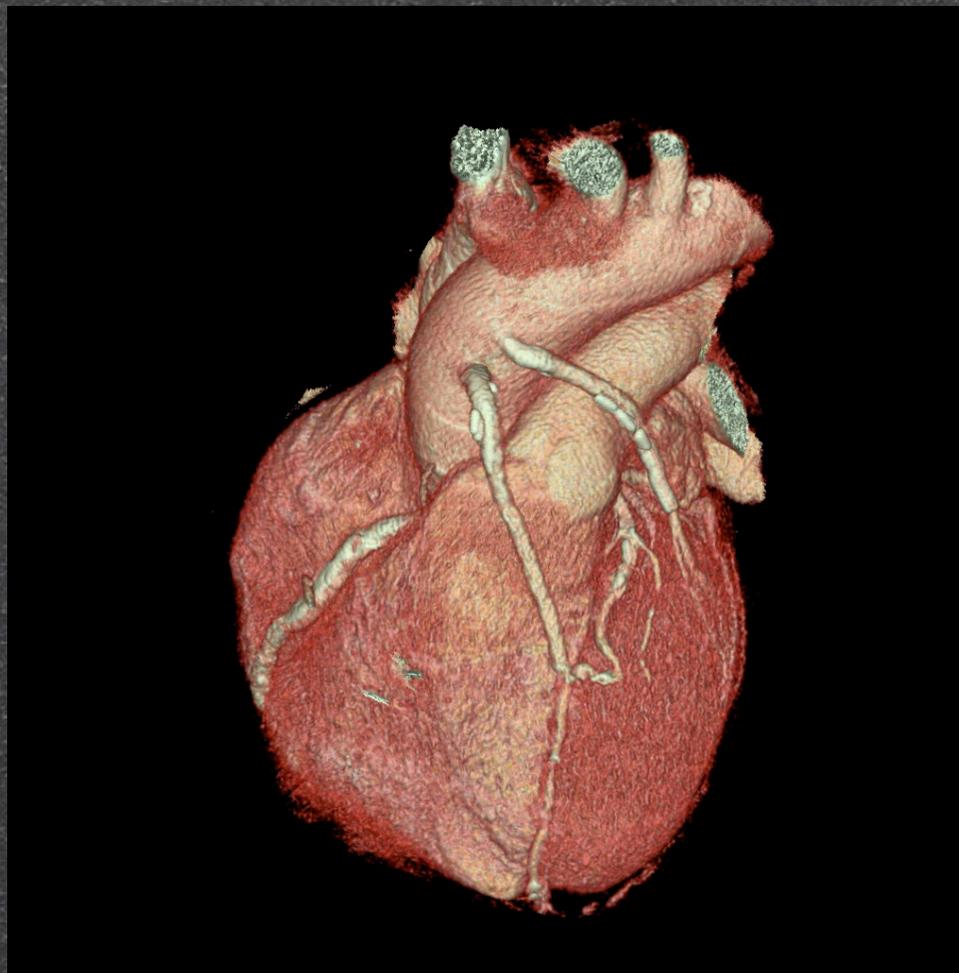
*SCA 11/11:
Fracture Stent BMS (Titan) / DES (Xience)*

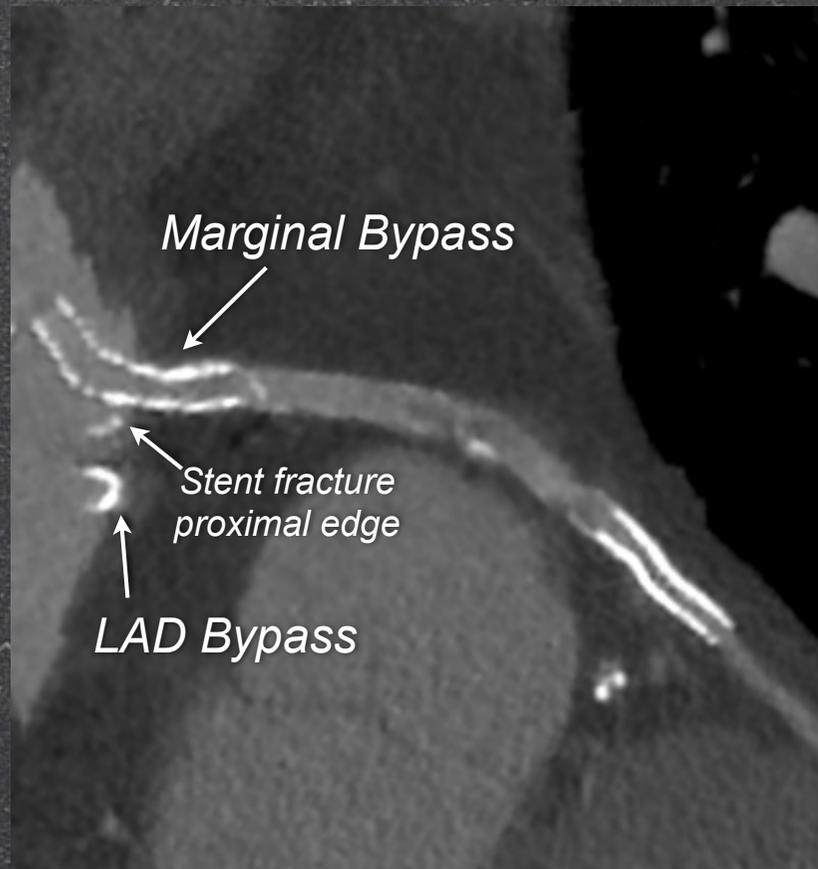
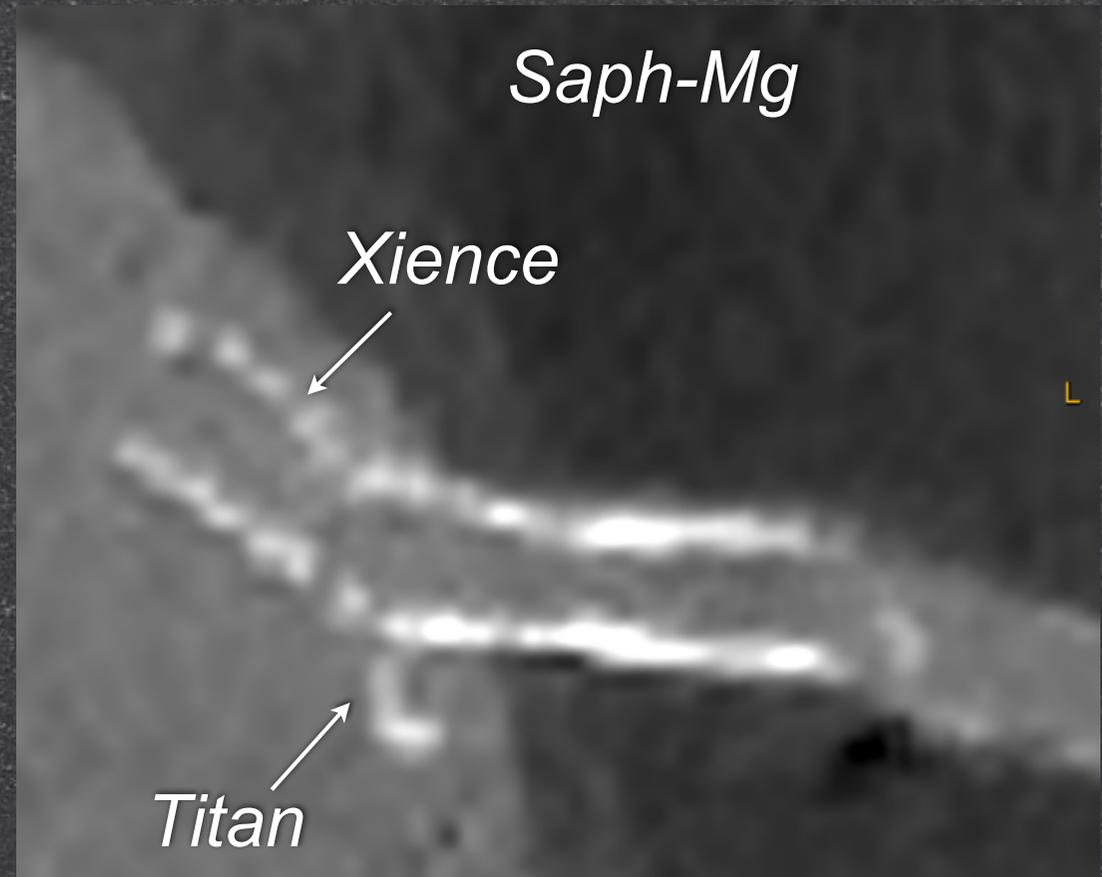
Fracture du Titan(ic) 2D

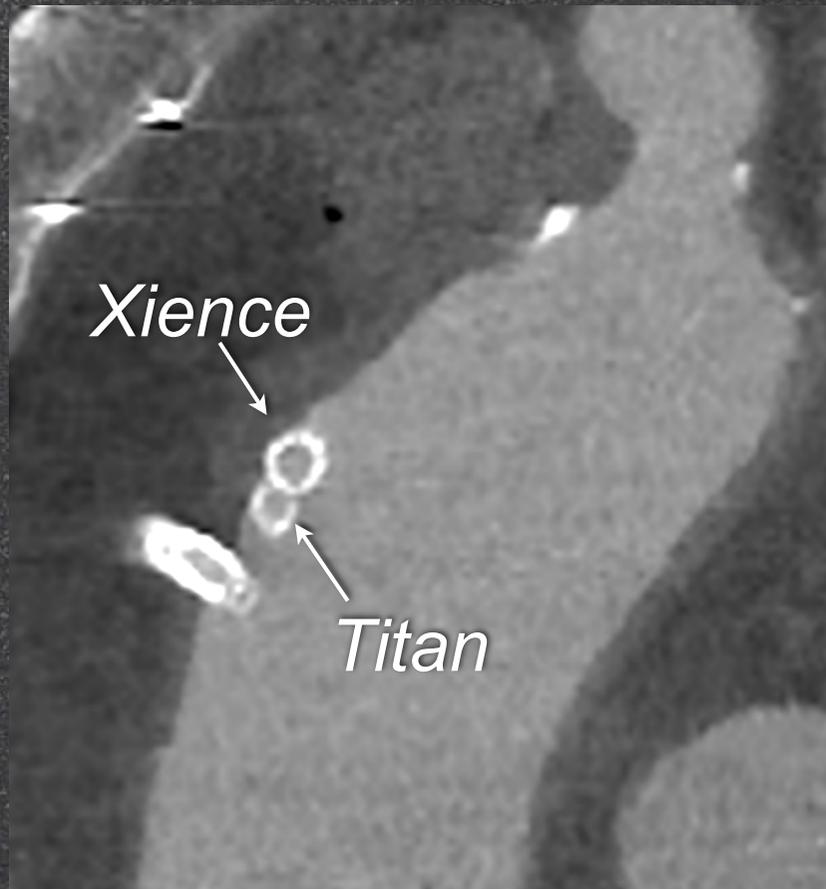
Fracture du Titan(ic) 2D

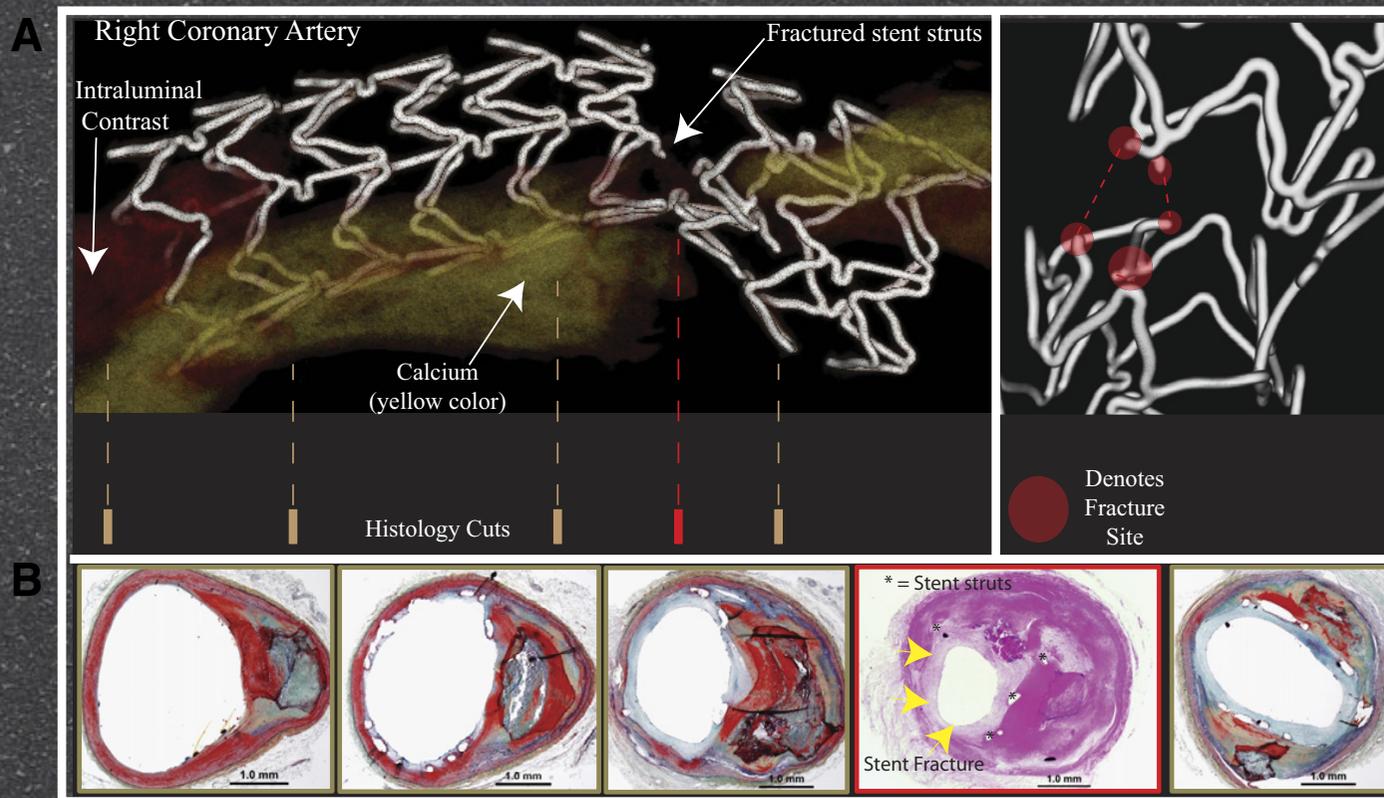
Figure 3. MicroCT and Histology Findings in the RCA

(A) Micro-computed tomography (microCT) 3-dimensional reconstruction of the right coronary artery (RCA) stent with a magnified image of the fractured segment to the **right**. The **red dots** highlight fracture points, with the **dotted line** indicating the original connection. The calcified plaque is colored **yellow**, and residual intraluminal contrast is **red**. (B) Corresponding histological cross sections of the RCA stent demonstrating focal restenosis at the area of fracture, with inflammation and fibrin accumulation at areas of polymer displacement.
